# FEASIBILITY STUDY, DETAILED DESIGN AND PREPARATION OF TENDER DOCUMENTS FOR RADAT DAM, BARINGO COUNTY

Contract No. NIB/T/016/2013-14

## Geological and Geophysical Investigation Report

JULY 2014

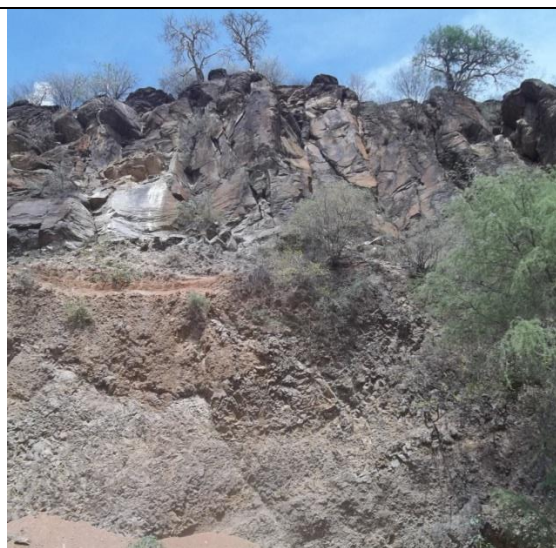
**Plate 2.2:** Young Basalts resting on completely weathered Old basalts (Samburu basalts)

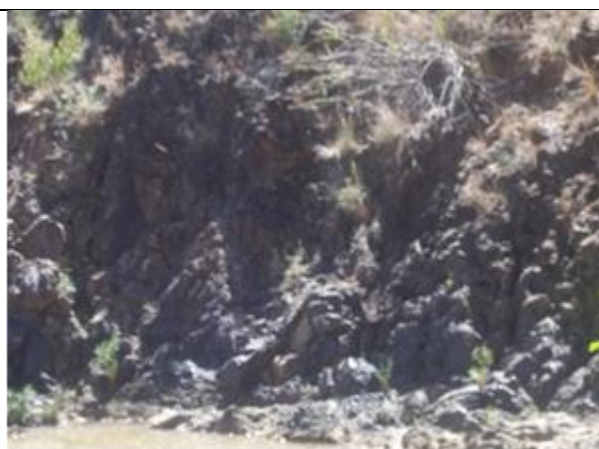
**Plate 2.3:** Highly weathered Samburu basalts upstream of the bridge site

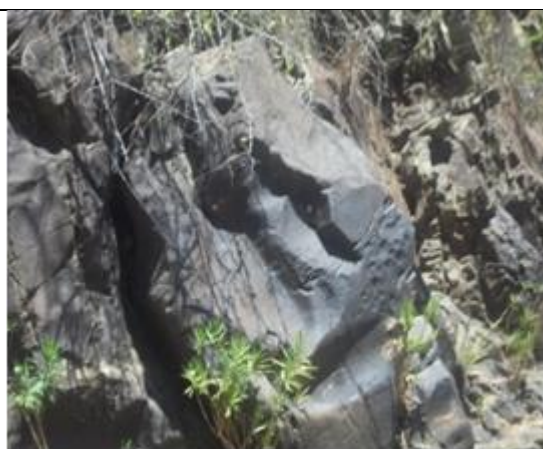
**Plate 2.4:** Phonolites resting on weathered basalts near the Bridge (dam site 3)

The rocks have disjointed lateral extent leading to absence of continuous bedrock as observed in geophysical investigations. Eldama Ravine tuffs and sediments are well exposed in proposed dam site 3 where sediments are intercalated with tuffs (Plate 2.4).

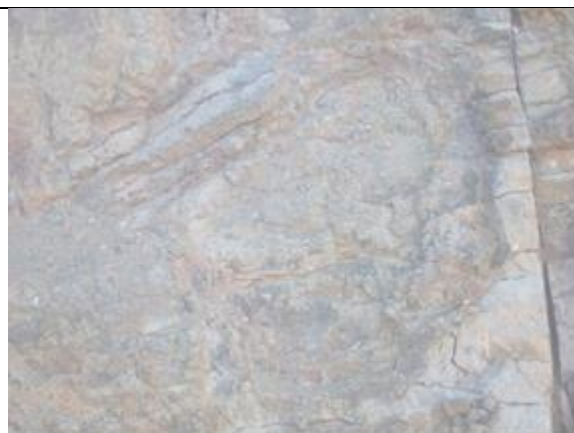
Plate 2.5: Intercalated tuffs and sediments  
Dam site 3 area

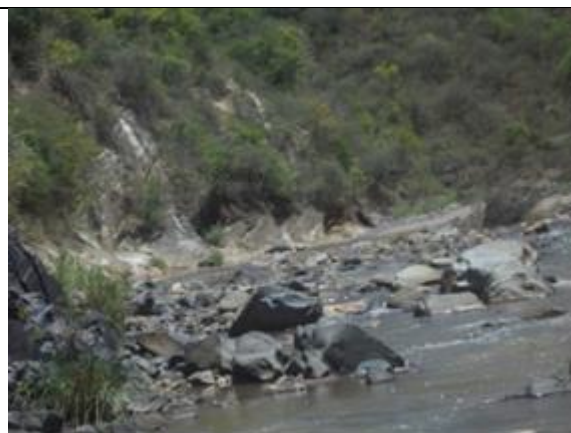
Plate 2.6: Intercalated tuffs and Sediments  
resting on basalts (Dam site 3 area)

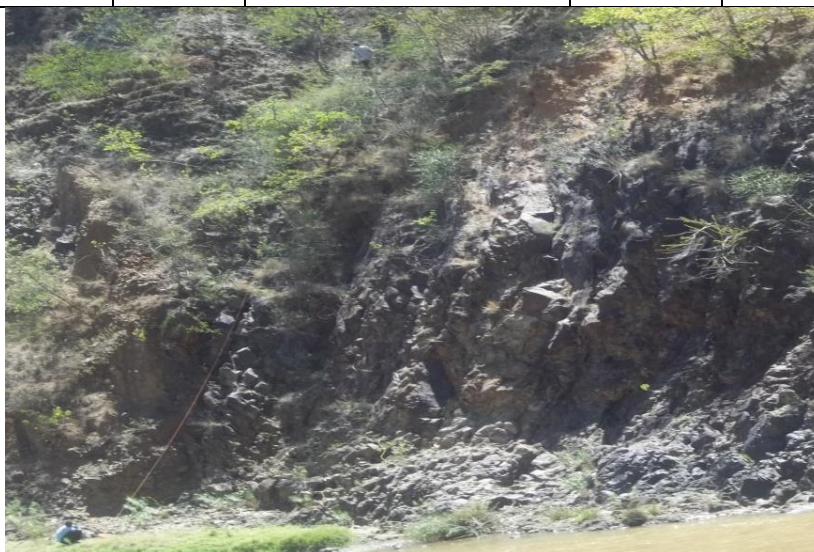
Figure 3:12 Geophysical investigations in progress at Dam site 3

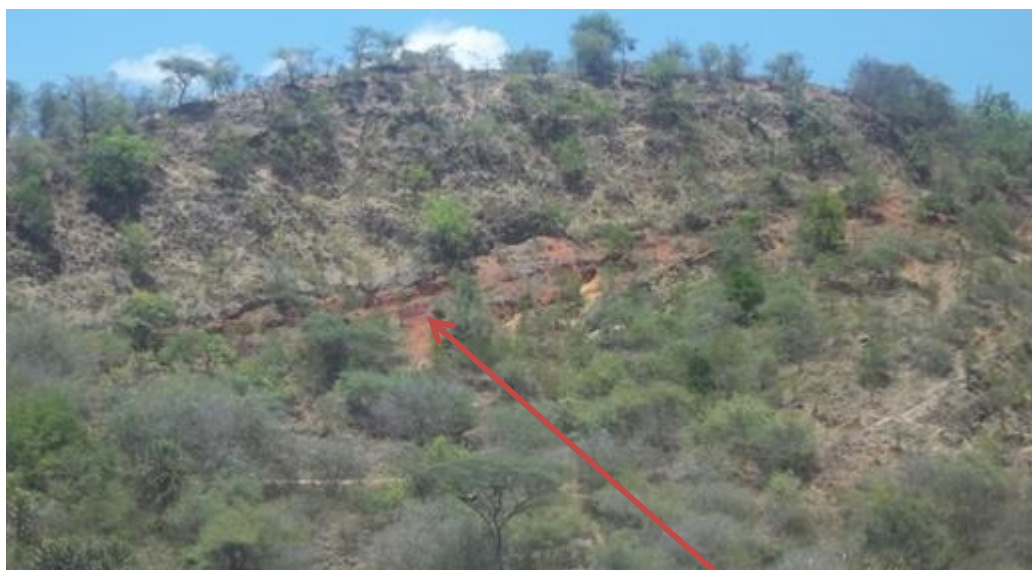
**Figure 4:1** A Layer of Red Clay Soil in Tuffs and Sediments (Soil sample collected here)

One particular soil sample seems to have promising characteristics was collected from TP near the Bridge (Kipting). This area is recommended detailed soil investigation by auger method. A spot of this area is shown in the figures below

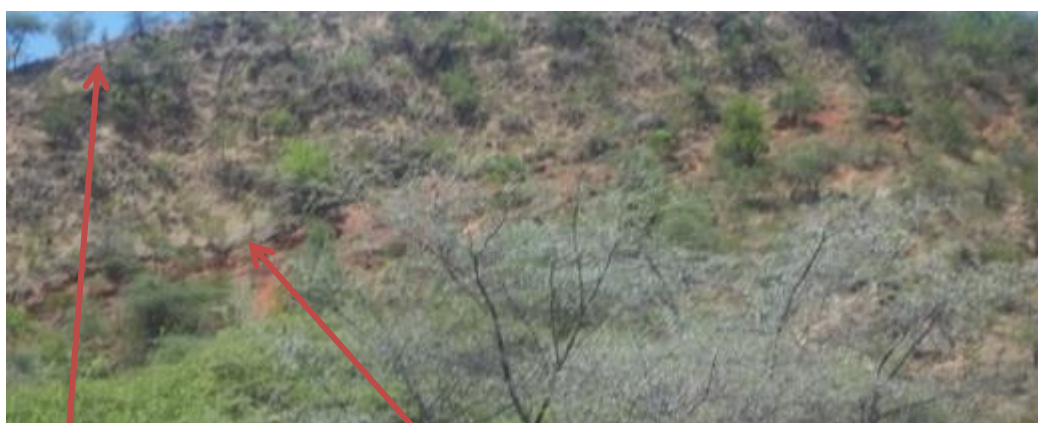
**Figure 4:2** A Layer of Red Clay Soil – same above sowing overlying Basalts
